BELTZVILLE LAKE CONDITION REPORT, DAM, OUTLET WORKS AND SPILLWA--ETC(U)

LEHIGH RIVER BASIN  
POHOPOCO CREEK, PENNSYLVANIA  
**BELTZVILLE LAKE**

CONDITION REPORT

DAM, OUTLET WORKS & SPILLWAY,  
PERIODIC INSPECTION REPORTS NO. 3 & NO. 4,  
SEPTEMBER 1972 & AUGUST 1973

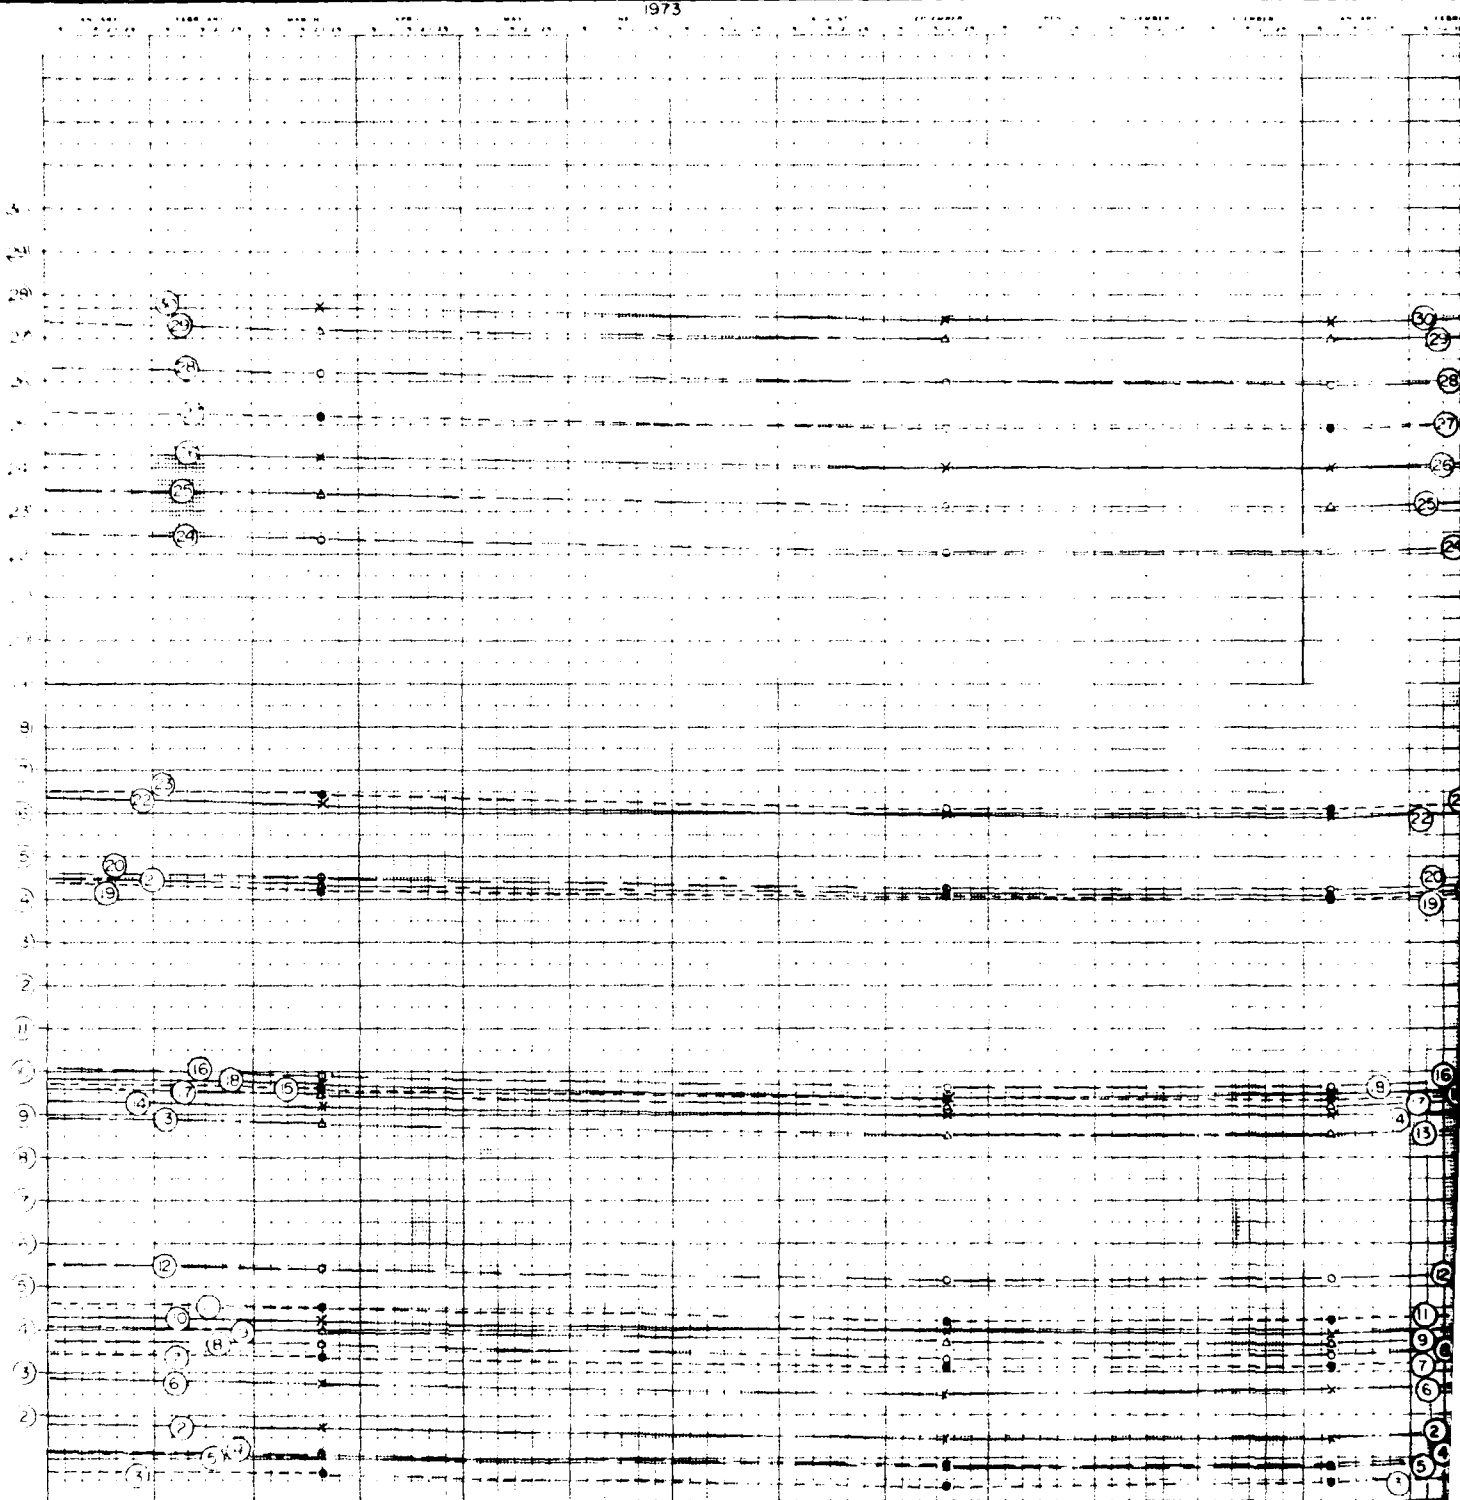
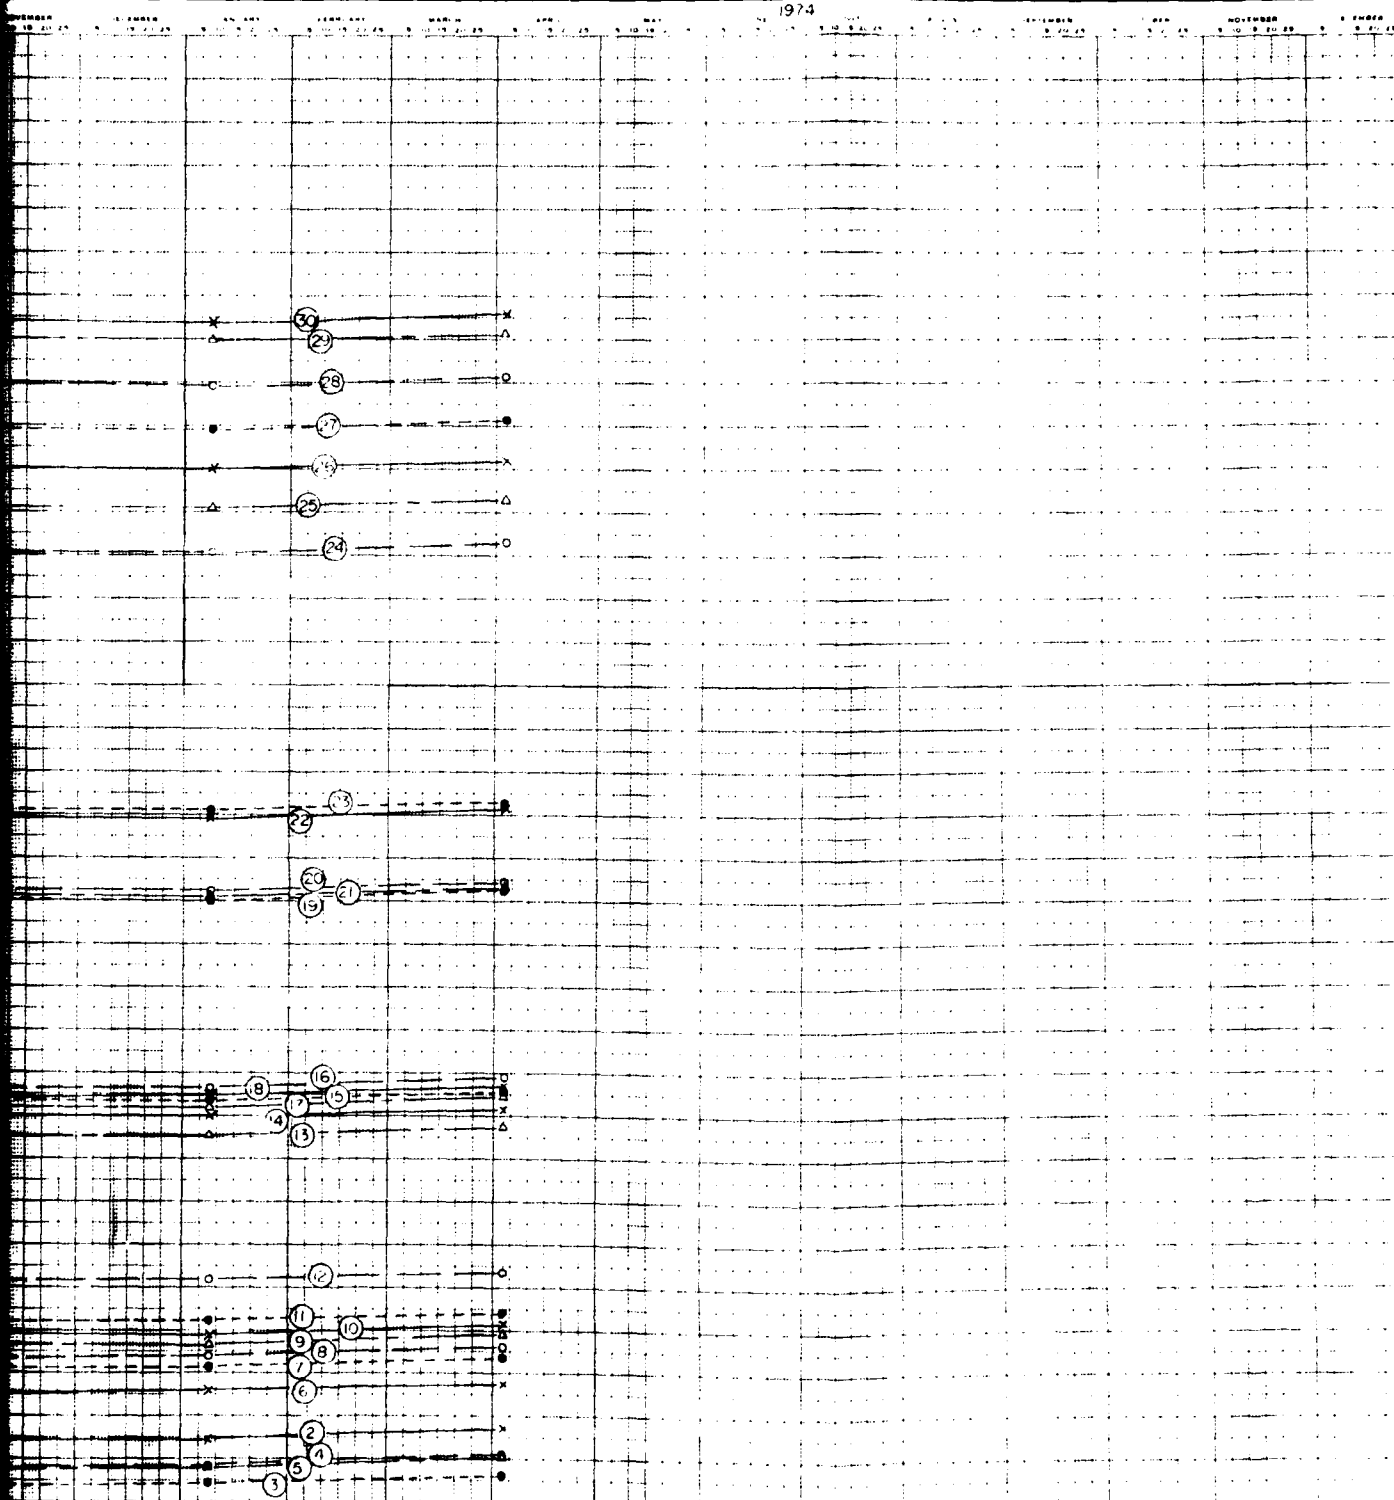
LEHIGH RIVER BASIN  
POHOPOCO CREEK, PA.  
BELTZVILLE LAKE  
SUBSURFACE SETTLEMENT DATA  
VIF - 92 - 2 1973-1974

- Initial datum for settlement of section casing (2)

< Measured settlement in section casing (2)

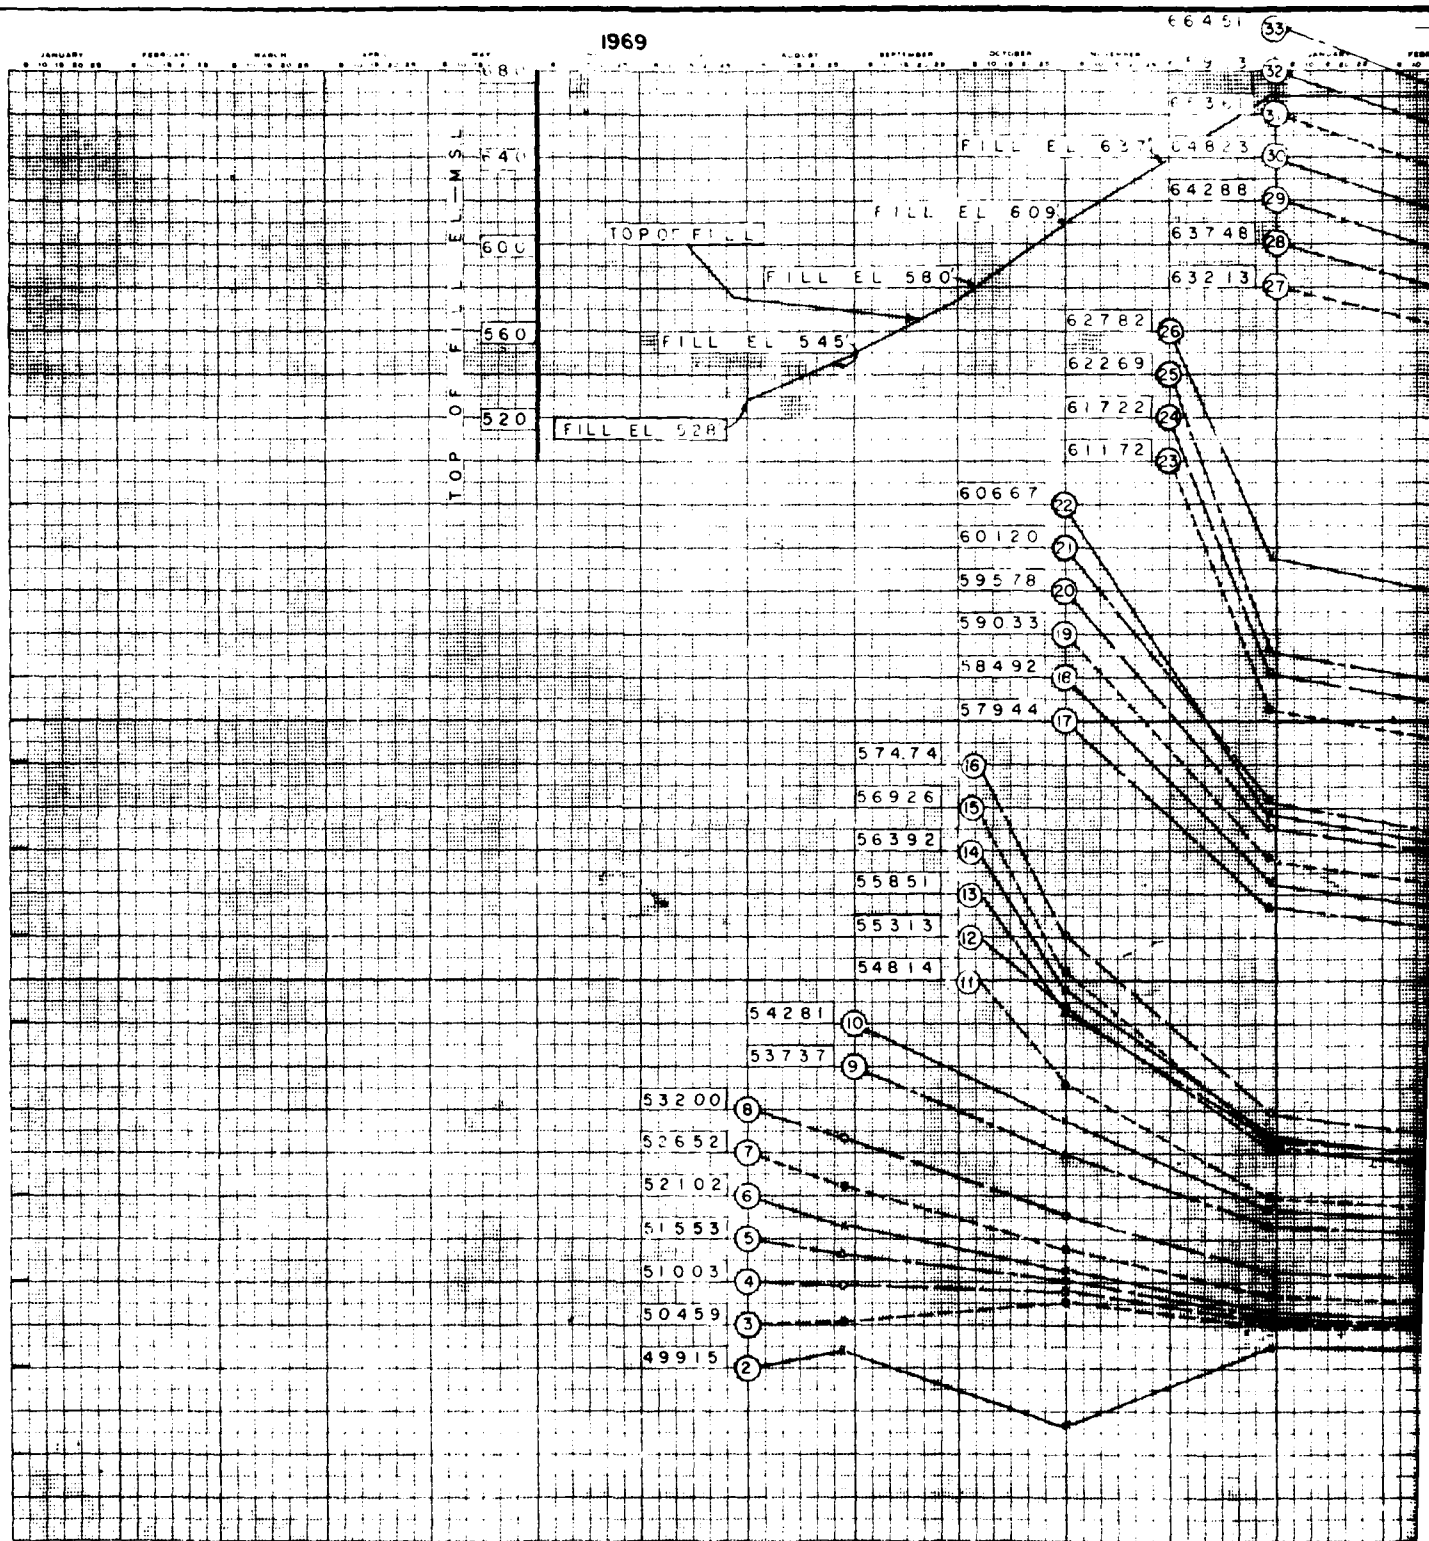
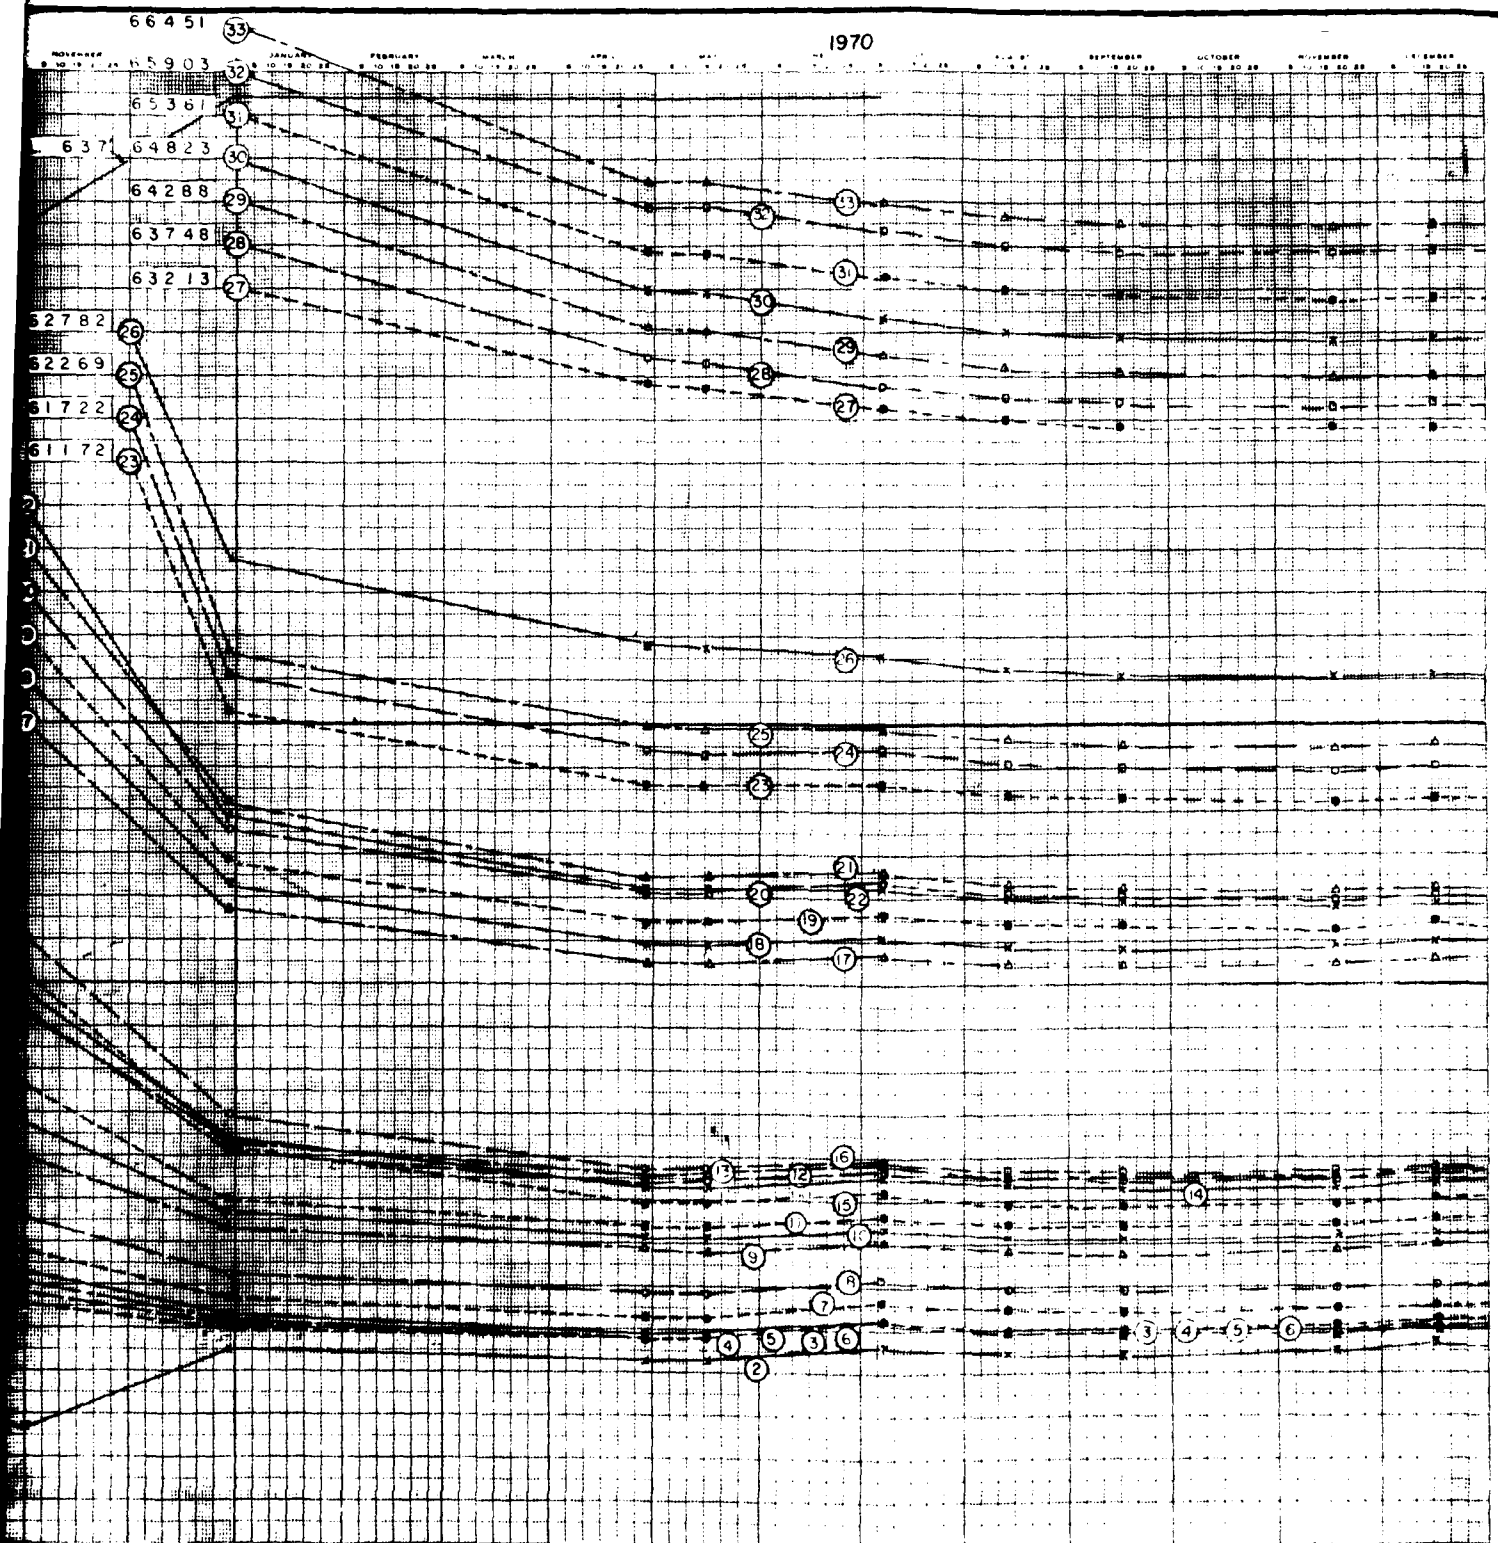
LEHIGH RIVER BASIN  
POHOPOCO CREEK, PA.  
BELTZVILLE LAKE  
SUBSURFACE SETTLEMENT DATA  
VIF - 95 - 2 1969 - 1970

NOTE 49915 (2) - INITIALLY INSTALLED BOTTOM  
ELEVATION FOR POINT 11.

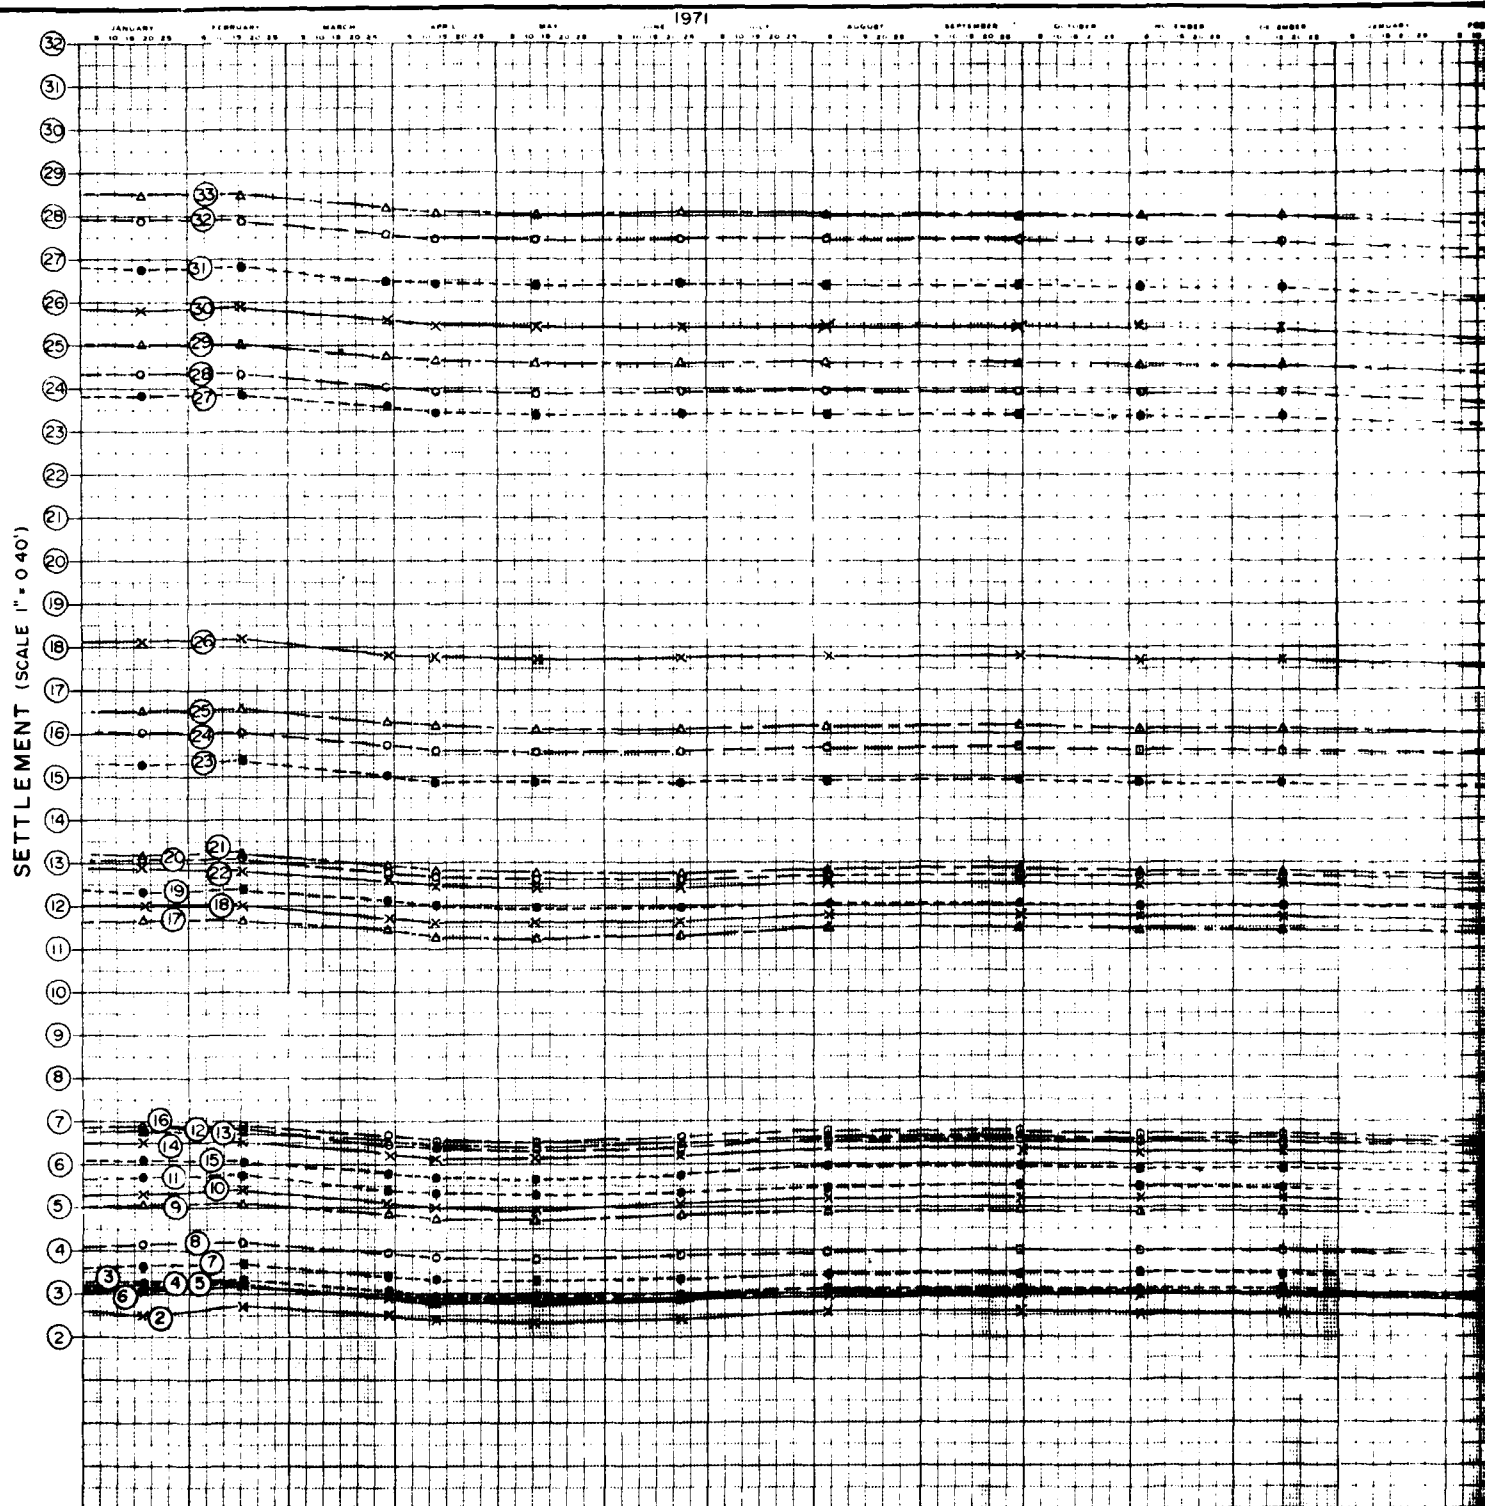
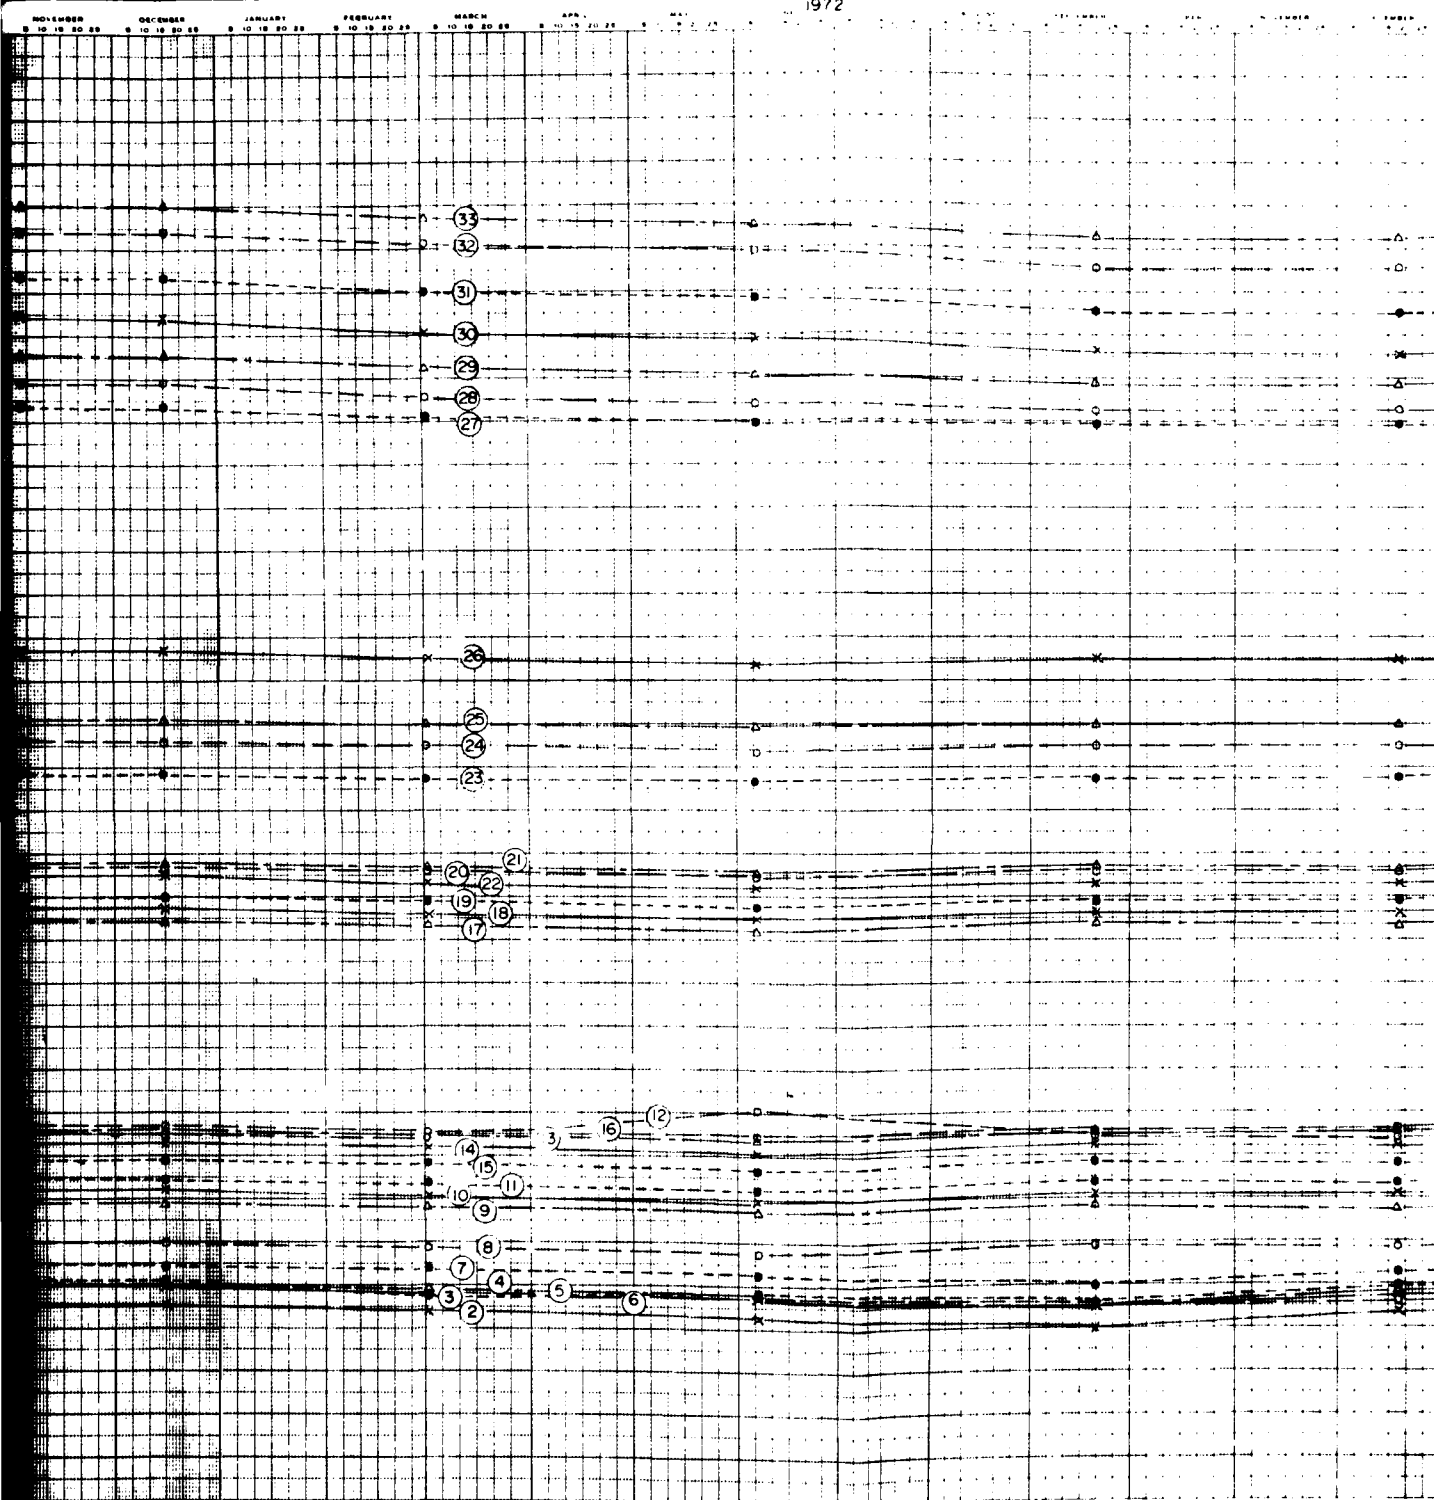
LEHIGH RIVER BASIN  
POHOPOCO CREEK, PA.  
BELTZVILLE LAKE  
SUBSURFACE SETTLEMENT DATA  
VIF - 95 - 2      1971 - 1972

Initial datum for settlement of section casing ②

Measured settlement in section casing ②

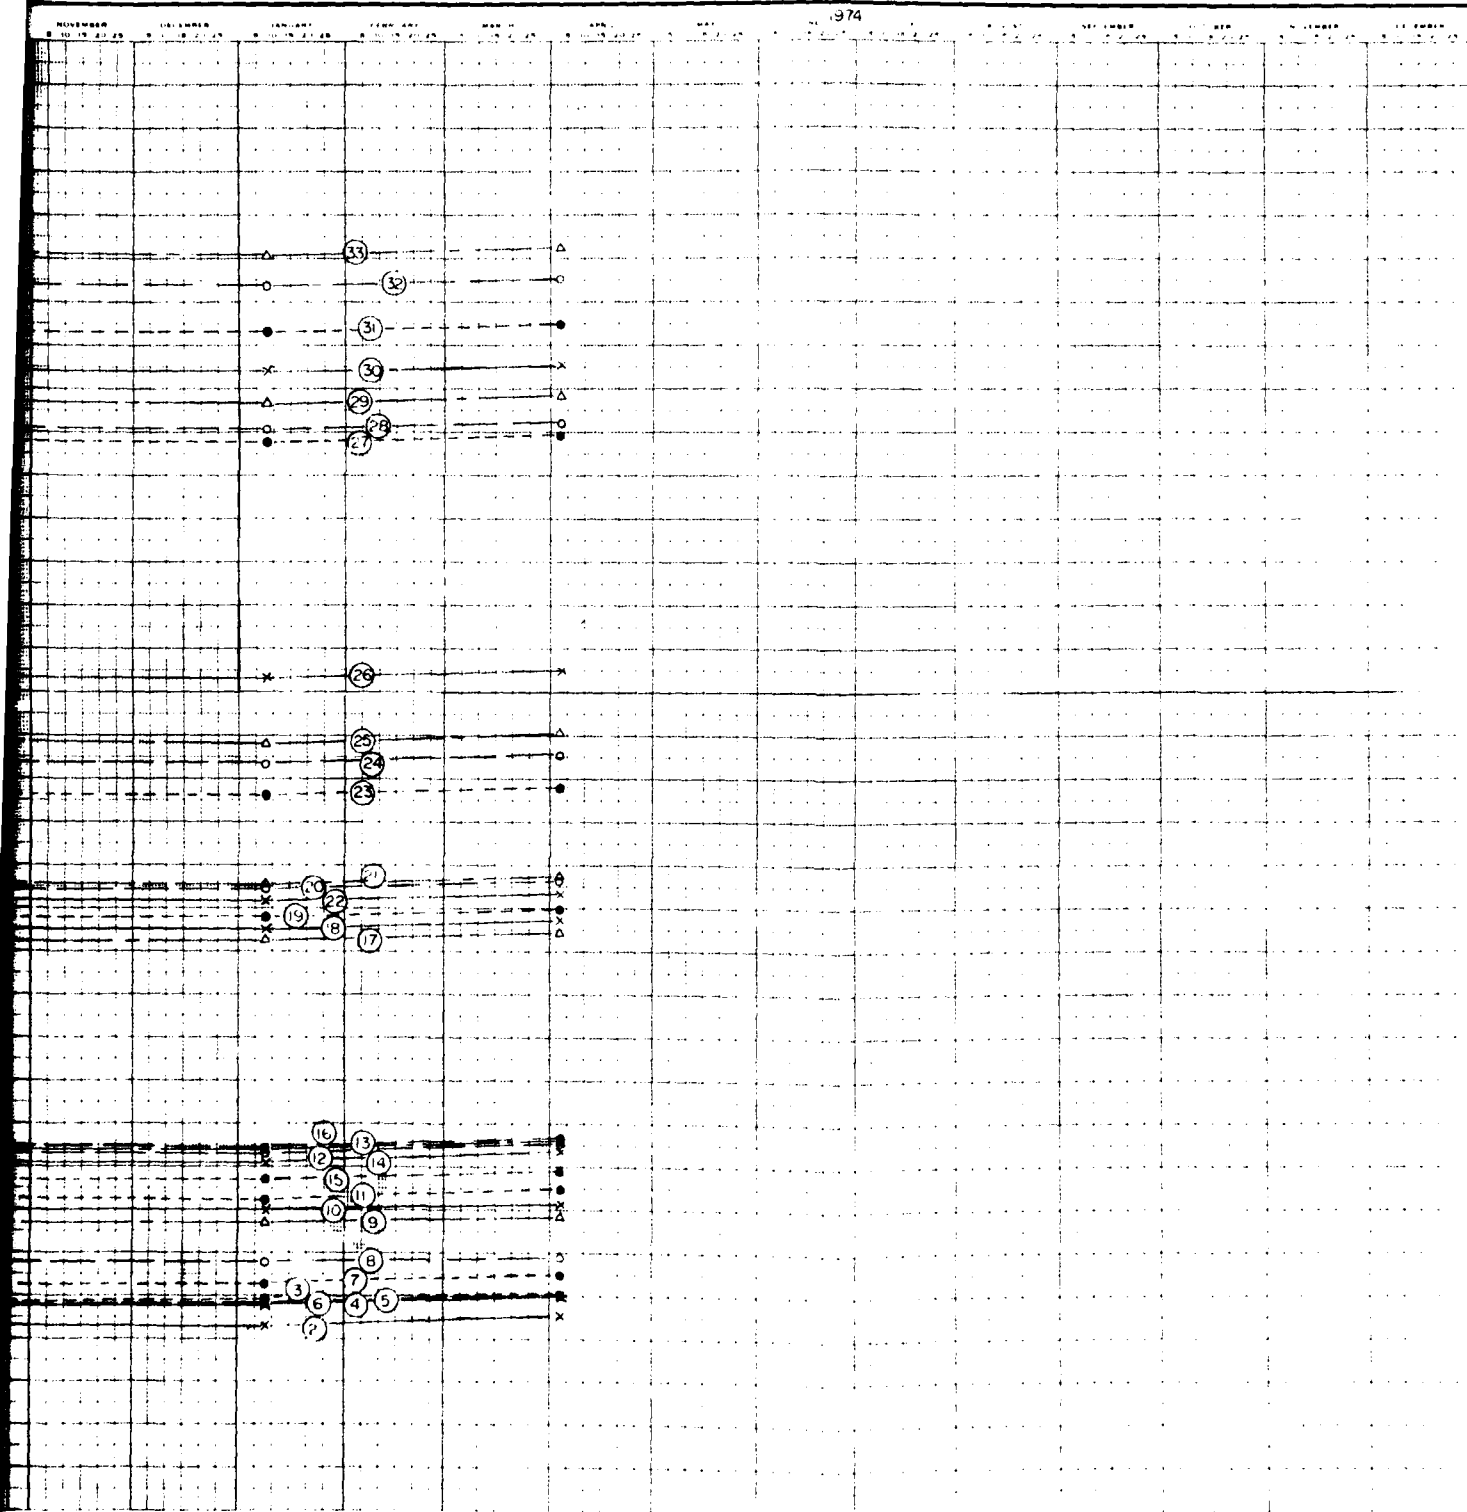
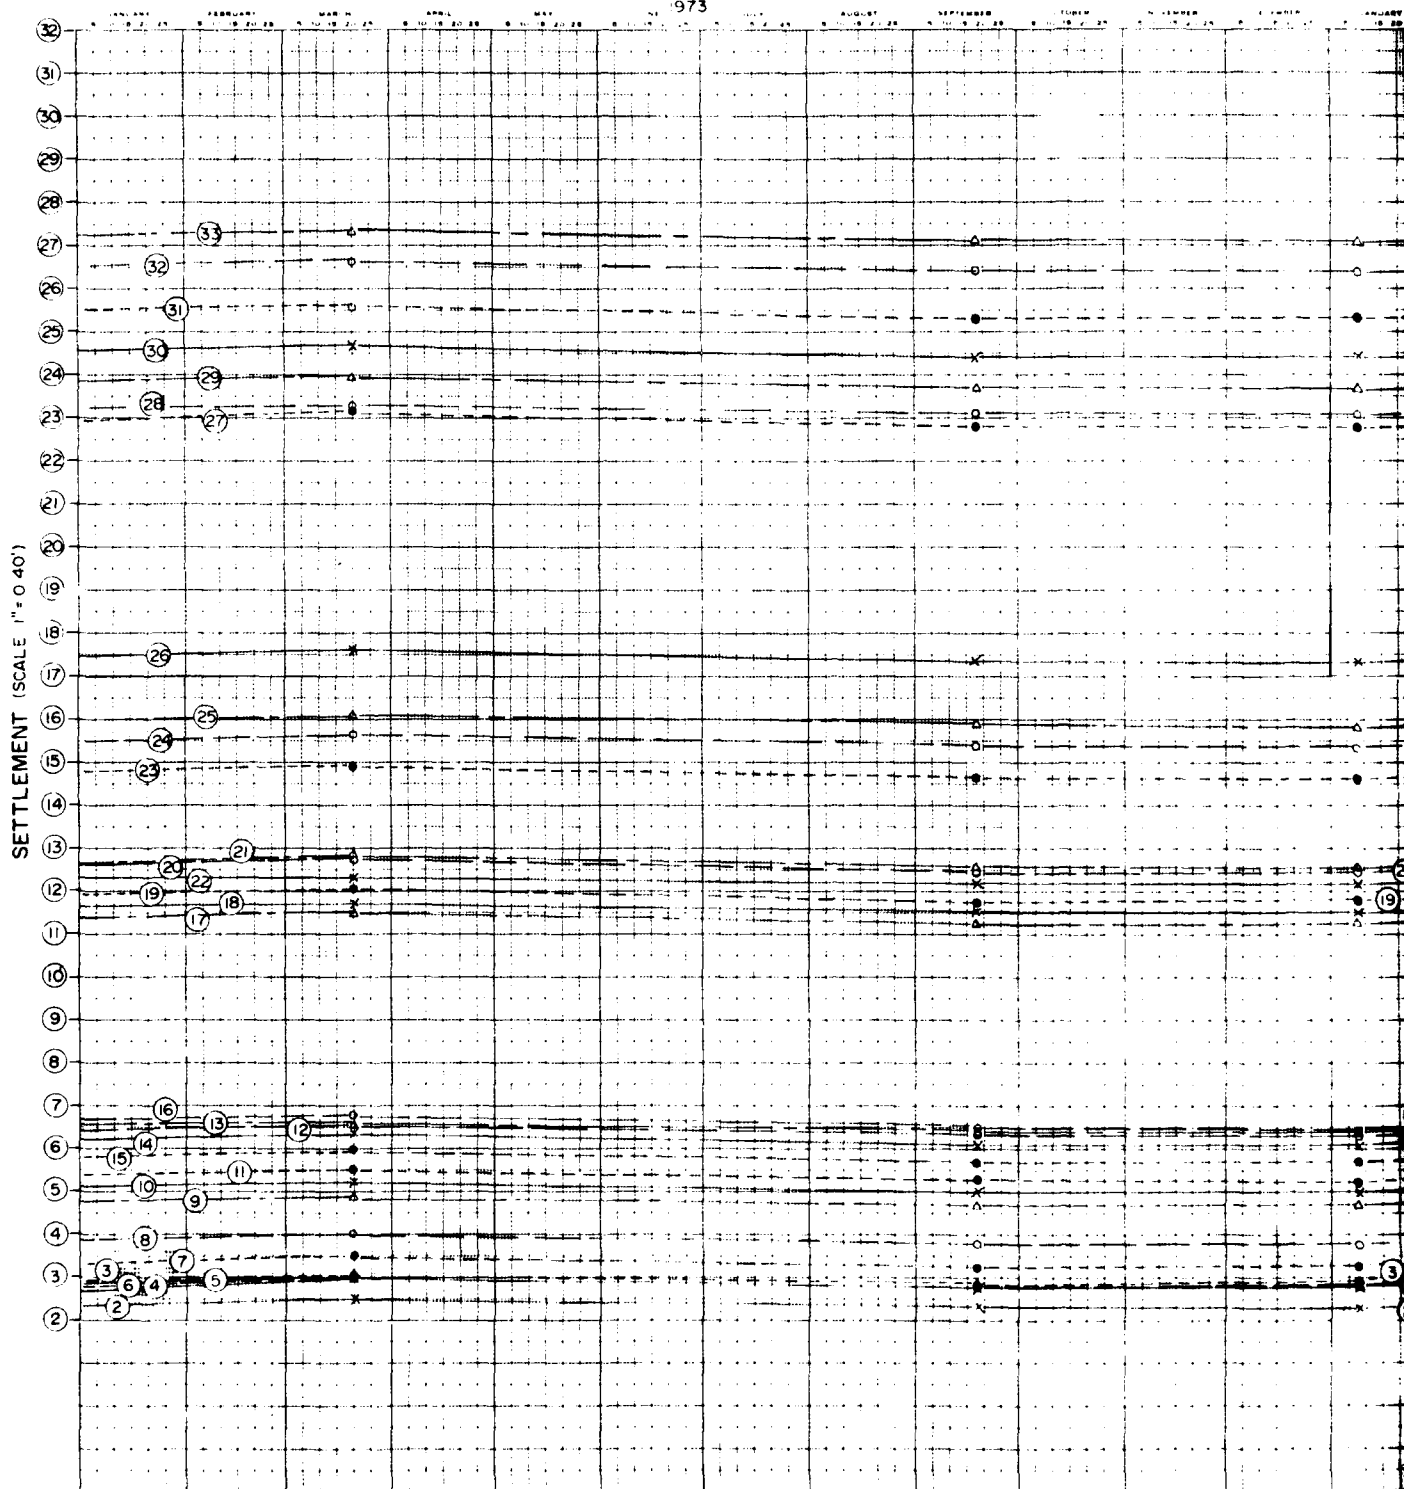
LEHIGH RIVER BASIN  
 POHOPOCO CREEK, PA  
 BELTZVILLE LAKE  
 SUBSURFACE SETTLEMENT DATA  
 VIF - 95 - 2      1973 - 1974

Initial datum for settlement of section casing (2)

Measured settlement in section casing (2)

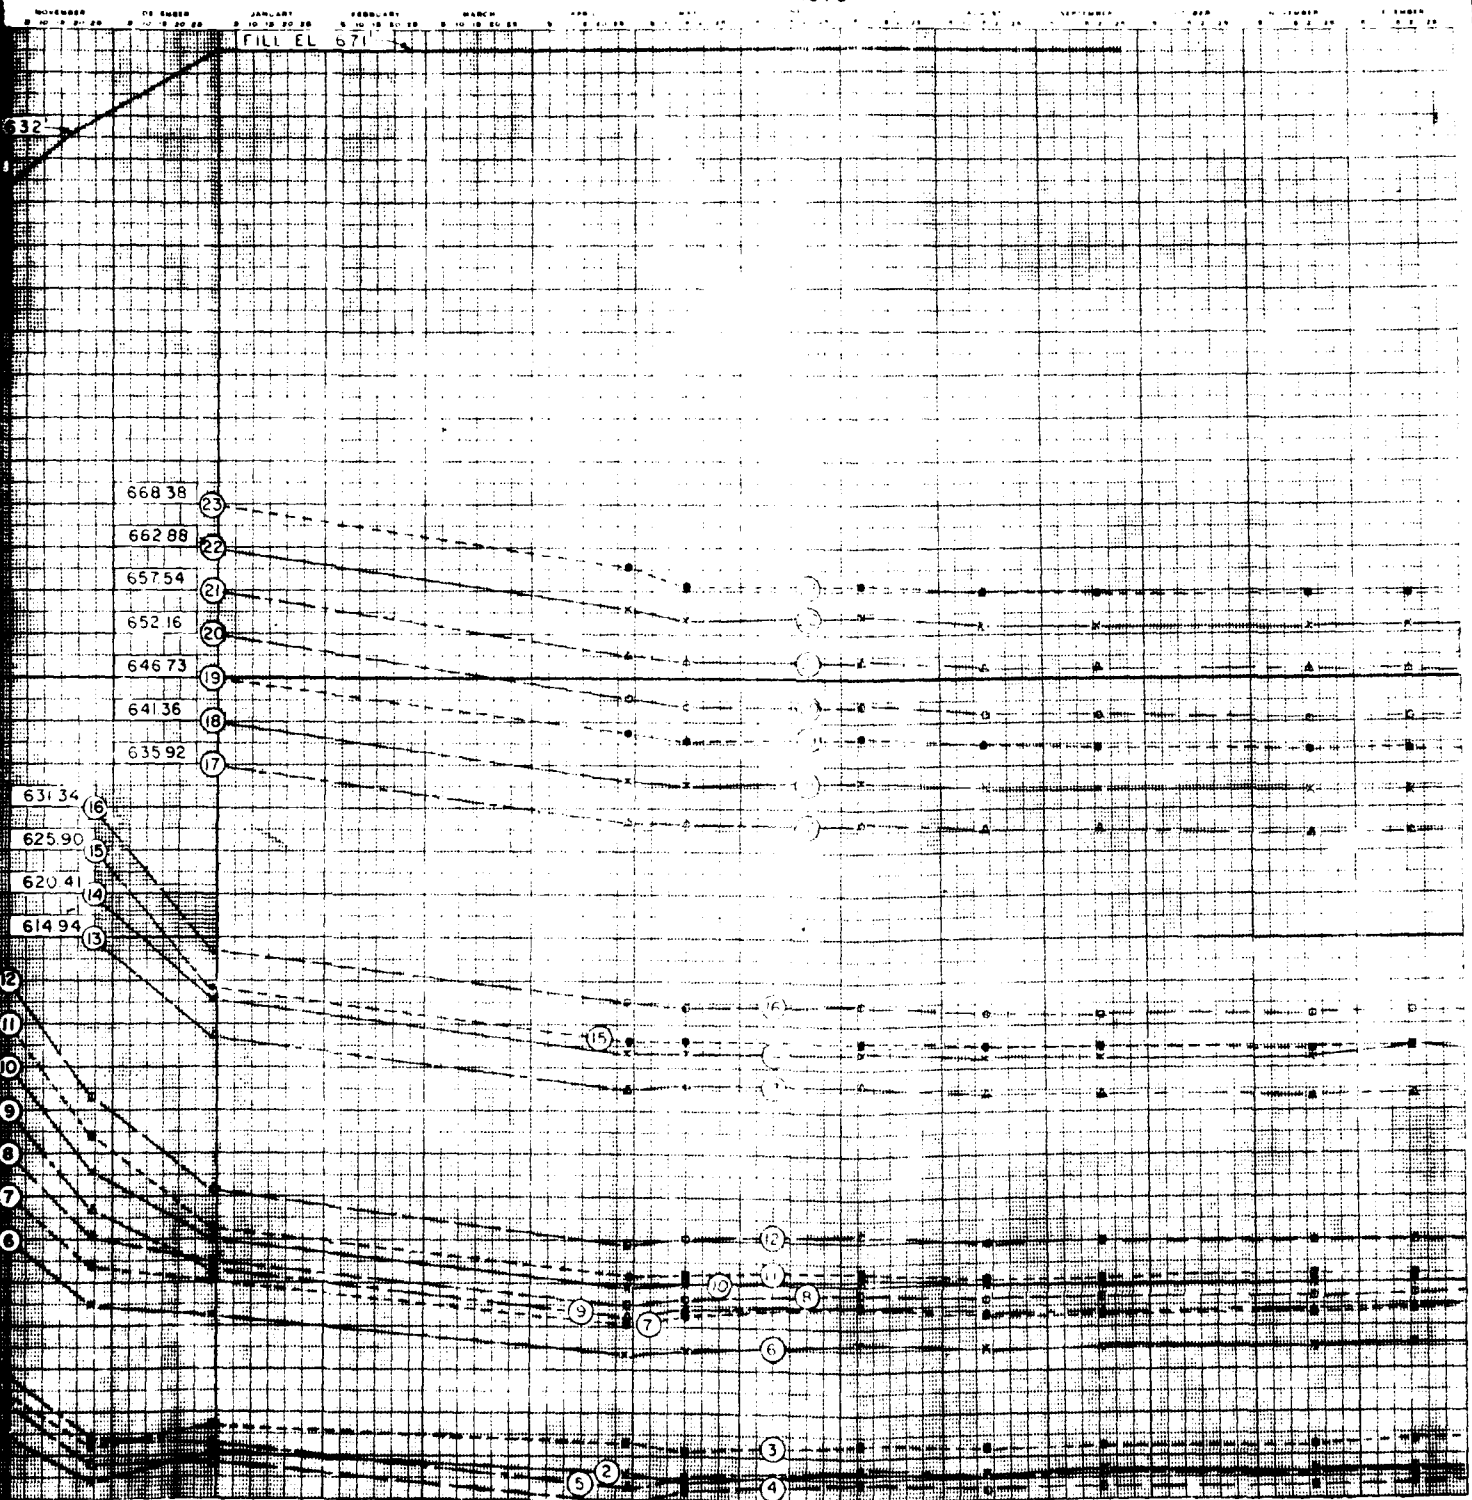
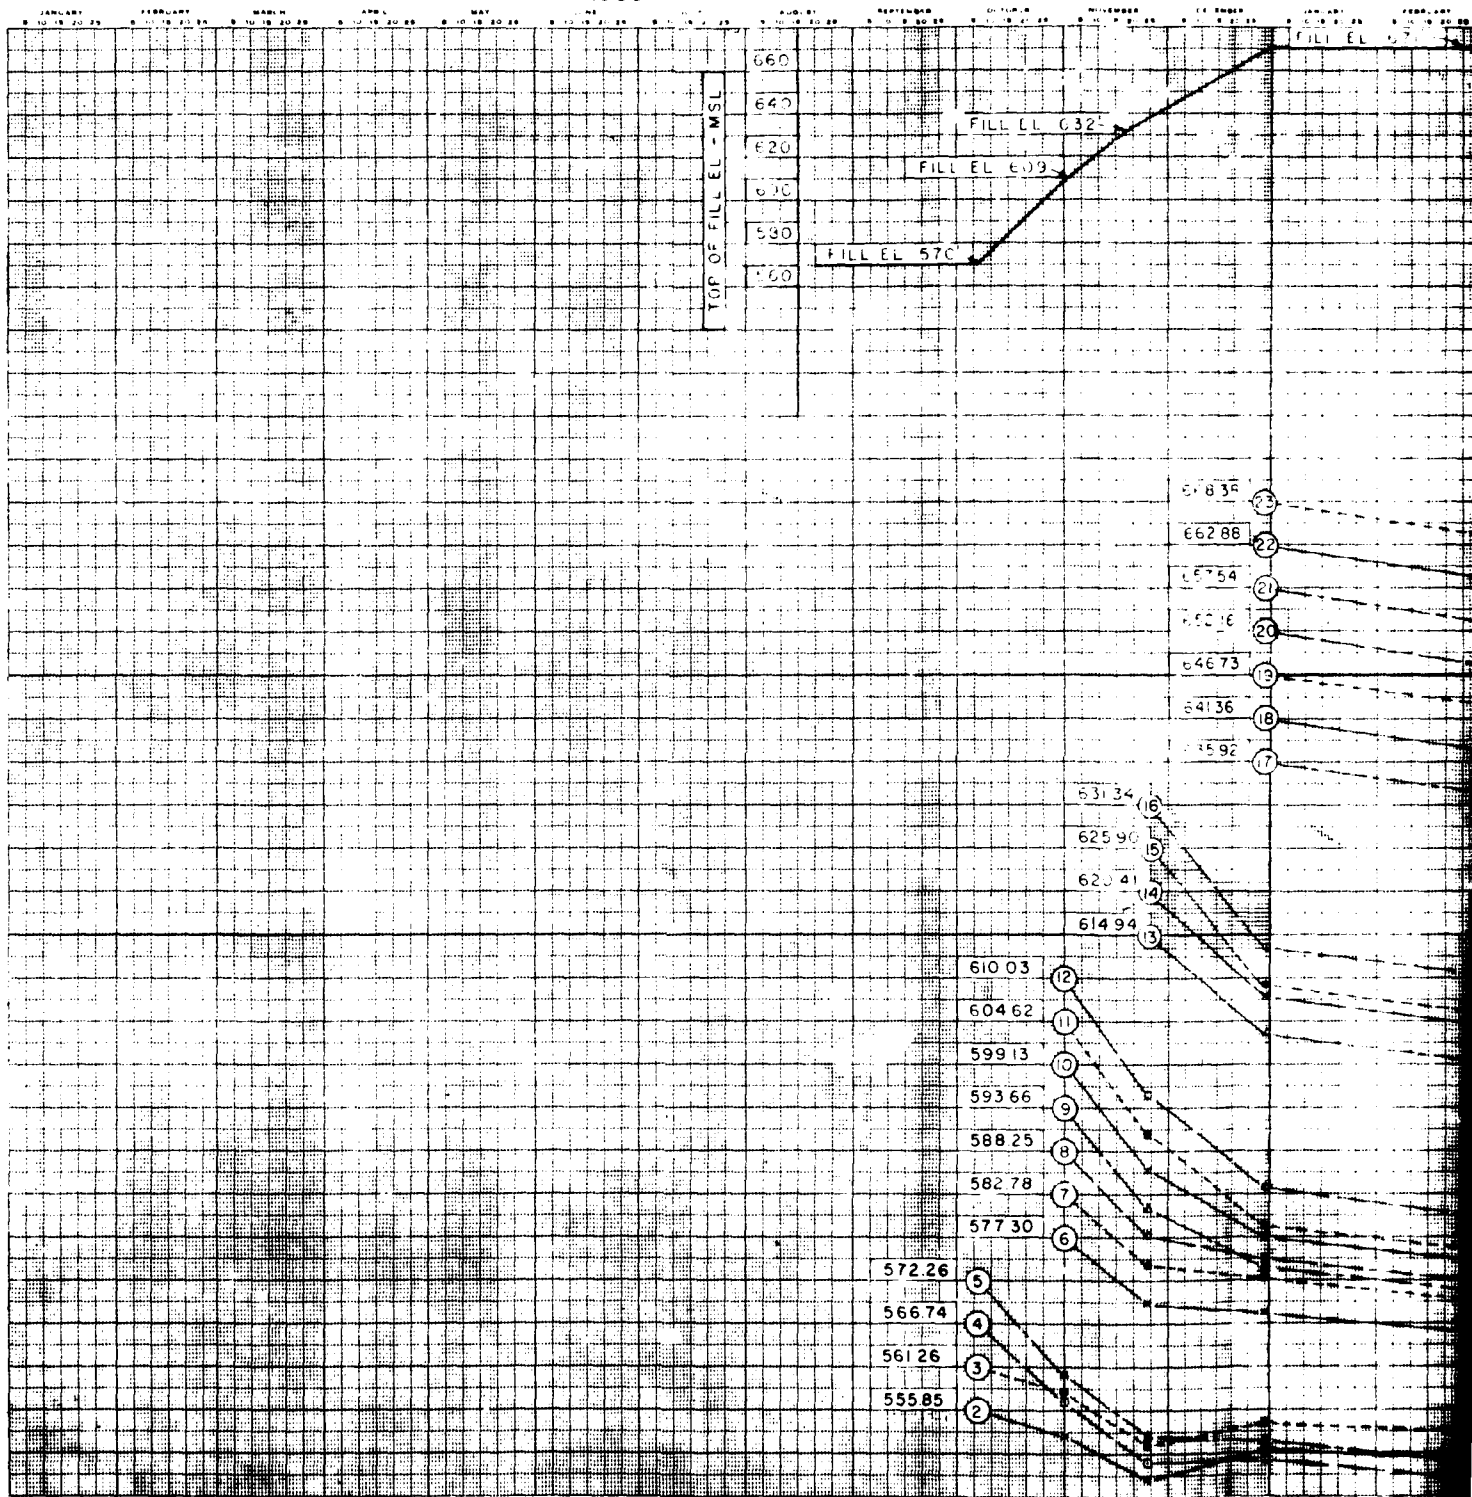
LEHIGH RIVER BASIN  
POHOPOCO CREEK, PA  
BELTZVILLE LAKE  
SUBSURFACE SETTLEMENT DATA  
VIF-98-5 1969-1970

NOTE  
555.85 ② = INITIALLY INSTALLED BOTTOM  
ELEVATION FOR CASING #2
